1. ACCELERATOR

1.1 PELLETRON

1.1.2 MAINTENANCE AND DEVELOPMENT ACTIVITIES

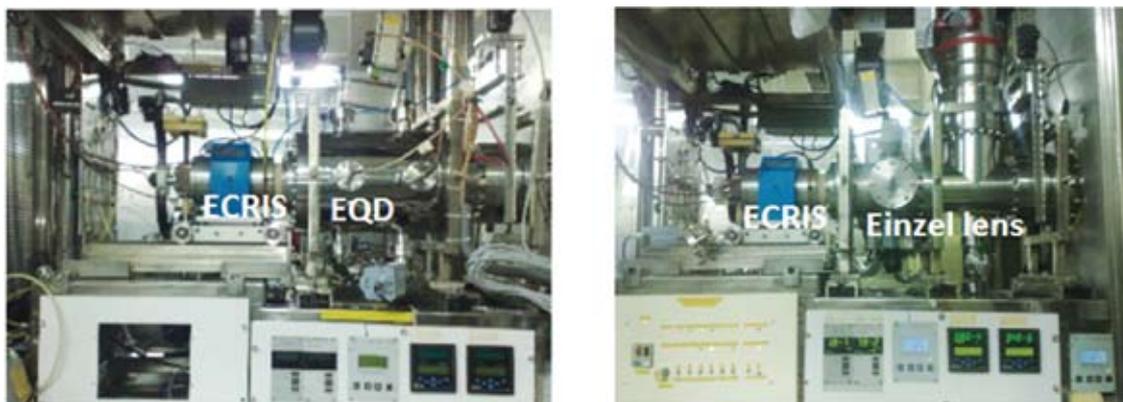
Fig. 7 Inside view of high voltage platform. The EQD (shown in left side image) has been replaced with Einzel lens (Right side image)

In this academic year, electrostatic quadrupole doublet (EQD) installed after the extraction system was replaced with an Einzel lens. The EQD acts as a strong steer if beam deviates from the central trajectory. Due to this, post beam line components viz. guard rings of the accelerating column, aperture of beam profile monitor etc were getting exposed to the beam causing beam loss and instabilities. With Einzel lens, which provide gentle focusing effects, this problem has been minimized. Further, beam transmission was found to increase from $\sim 37\%$ to $\sim 60\%$. The view of ECR ion source on the high voltage platform along with extraction and focusing system is shown in figure 7.
