1. ACCELERATOR

1.1 PELLETRON

1.1.2 Maintenance and Development Activities

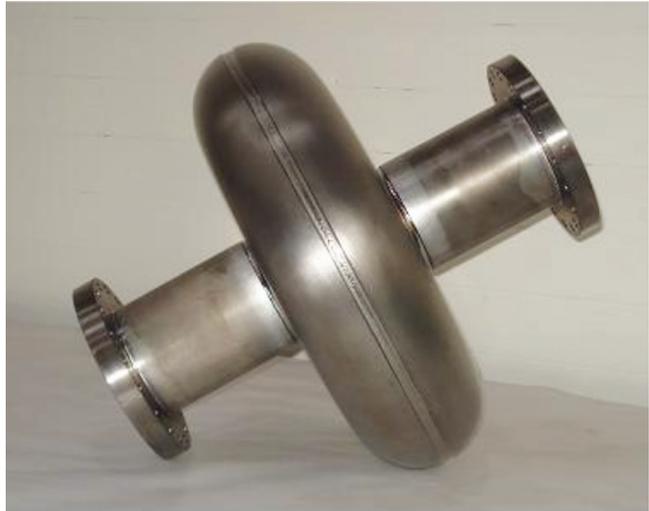
Under the Indian Institutions and Fermi Lab Collaboration (IIFC), Variable Energy Cyclotron Centre (VECC), Kolkata and IUAC have developed a $\beta=0.61$, 650 MHz single cell niobium low beta cavity (LBC). In addition to sharing its facilities, IUAC also shared its technical expertise with VECC for developing the cavity. The cavity components were formed and machined by VECC while the electron beam welding (EBW) was done by IUAC. The half cells of the cavity were joined together at the equator by welding from outside (non-RF side) and inside (RF side). This resulted in the two iris joints to be done as full penetration welds from outside. In Figure 1.2.4, the first niobium cavity developed, is shown. The cavity has been sent to Fermilab for processing and testing at 2K. It is planned to build a second single cell niobium cavity by performing the equator EBW from outside (non-RF side) as a full penetration weld and instead weld the iris joints as partial welds from outside (non-RF side) as well as inside (RF side). This procedure will help in the eventual goal of developing a 5-cell niobium cavity.

Fig. 1.2.4 First 650 MHz, $\beta=0.61$ niobium single cell low beta cavity

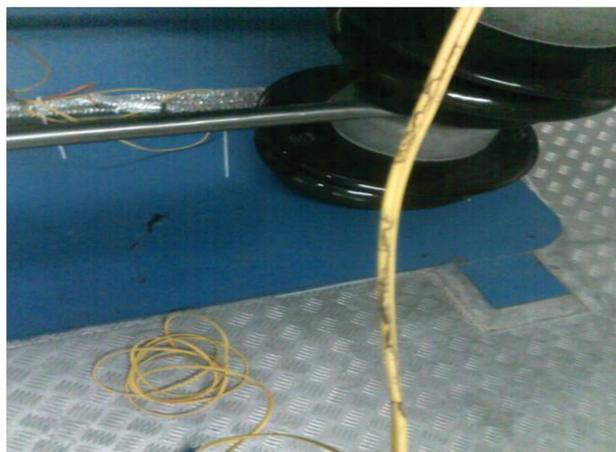
During the current academic year, as such there has not been any major break down in the facility except the failure of the fiber optical cable controlling the extractor and Einzel power supplies at the high voltage platform. Repeated sparks during the source operation at limiting platform voltage seem to be the main reason for the cable damage. A view of the damaged fiber optical cable is shown in Figure 1.3.5. The damaged cable was replaced with a new one and the source operation was continued for regular experiments.

Fig. 1.3.5 A view of the damaged fiber optic cable
