3. RESEARCH SUPPORT FACILITIES

3.1 SUPPORT LABORATORIES

3.1.1 HIGH VACUUM LABORATORY

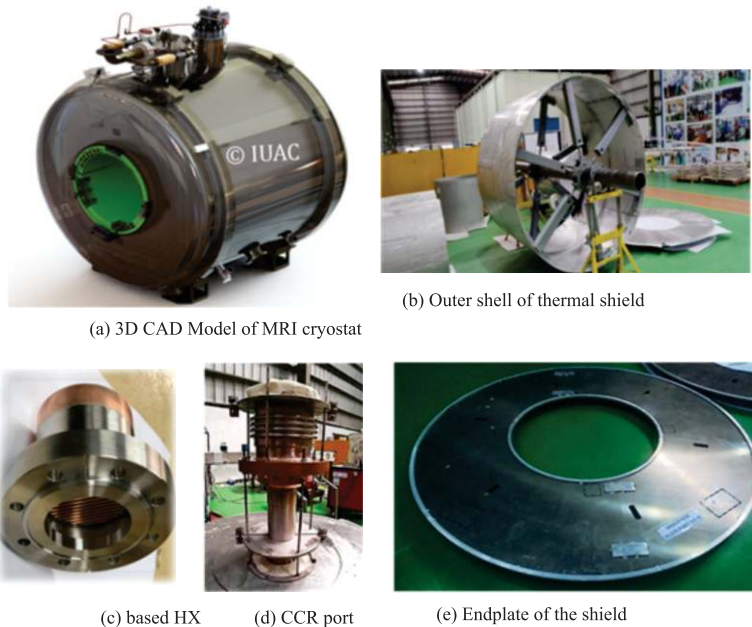
Fig. 3.6 Various components fabricated for the zero-boil-off MRI cryostat.

Fig. 3.6(a) shows the 3D CAD model of the Zero-Boil-Off (ZBO) MRI cryostat. The fabrication of the various components of the cryostat was completed to make it ready for integration with the magnet. Figures 3.6. (b) - (e) show the various major and minor components of the MRI cryostat fabricated in this academic year. A two-stage GM cryocooler (CCR) will be used to provide the cooling of the intermediate thermal shield and the refrigeration to the 4K to achieve ZBO condition. The first stage of the CCR is thermally connected to the intermediate radiation shield to maintain the temperature range of 40-50K. The outer shell and the end plates of the thermal shield are shown in Figures 3.6. (b) and (e). The ZBO condition is achieved by the localized recondensation of the helium vapor using a fin-based HX attached to the 2nd stage of the CCR. Fig 3.6(d) shows the CCR port of the cryostat.

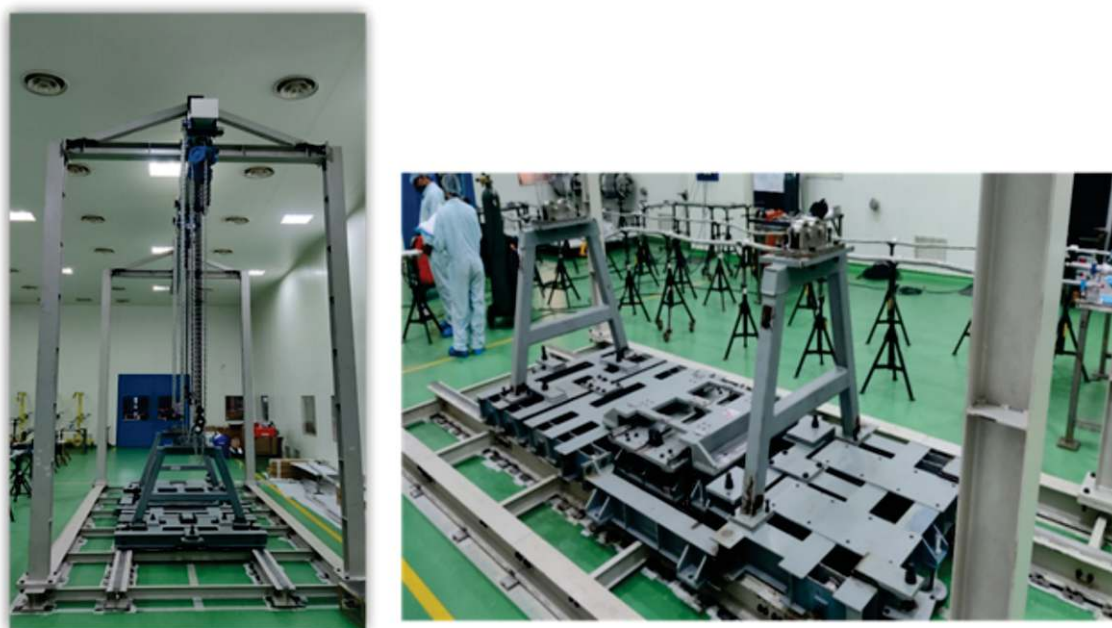
Fig. 3.8 The magnet-cryostat assembly station of the whole-body MRI magnet system.

Fig. 3.8 shows the assembly station fabricated for the integration of the magnet with the cryostat. The entire assembly sequence is divided into fifty major assembly steps having various intermediate tasks not limited to helium leak testing, pressure testing, MLI wrapping, sensor mounting, etc. The integration of the magnet and the cryostat will soon be started at the vendor's site at Vadodara.
