## **1. ACCELERATOR**

### **1.1 OPERATIONAL SUMMARY**

#### **1.2 MAINTENANCE AND DEVELOPMENT ACTIVITIES**

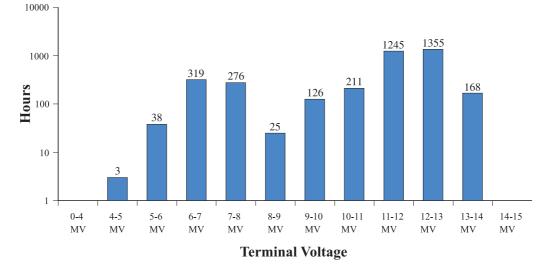
Fig. 1. Terminal voltage vs Hour curve

# **Terminal Voltage vs Hours Graph**

During the above mentioned period, a total number of 471 shifts was used for experiment. Out of these 471 shifts, 68 shifts were used for pulsed beam users. The machine uptime for this period is 95.56% and the beam utilization is 59.11%. The voltage distribution of the Terminal Potential used for different experiments in the year is shown in above Graph. The maximum voltage achieved during conditioning in this year was 14.2 MV.

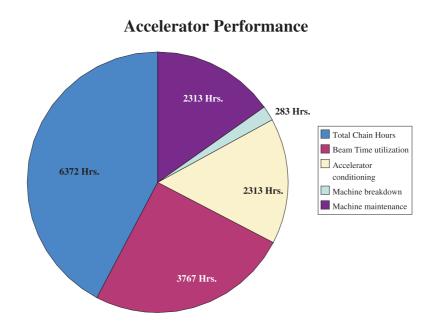
Fig. 2. Accelerator performance, in the form of Pi-chart

Total no. of Chain Hours	=	6372 Hours
Total Beam utilization	=	3767 Hours
Machine breakdown	=	0283 Hours
Accelerator Conditioning	=	2313 Hours
Beam Change Time	=	0009 Hours

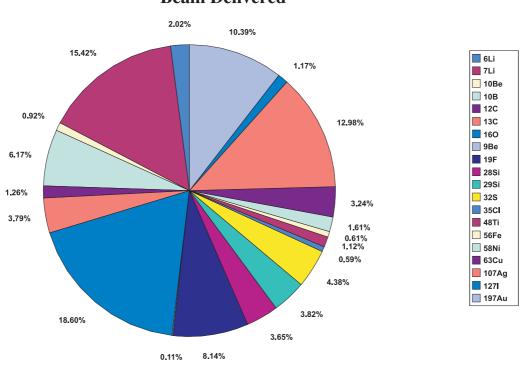
Fig. 3. Run Time for different ions (2005-2006)

The total duration of beam run for the mentioned period is 3767 hrs. Duration of run time in percentage for different ions is shown as below.

**Beam Delivered**

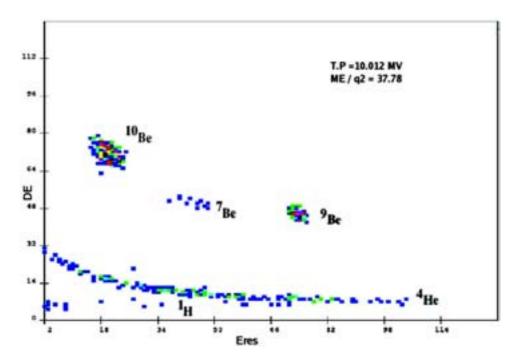
This year we took the final steps in <sup>10</sup>Be AMS facility development and in May 2005 we succeeded in detecting <sup>10</sup>Be from standard sample SRM 4325. In the measurement, simultaneous injection method was used by injecting mass 26, consisting mainly of <sup>10</sup>Be<sup>16</sup>O, <sup>9</sup>Be<sup>17</sup>O and <sup>9</sup>Be<sup>16</sup>OH. Maximum <sup>9</sup>Be<sup>16</sup>O current (mass 25) extracted from ion source was found to be 1.1uA. <sup>10</sup>B<sup>3+</sup> beam (from injected mass 26 as <sup>10</sup>B<sup>16</sup>O from a Boron cathode) was used as a pilot beam for tuning <sup>10</sup>Be<sup>3+</sup>. At the terminal, combination of gas and foil stripper was used and a maximum transmission of 19% with injected <sup>9</sup>Be<sup>16</sup>O<sup>-</sup>, and <sup>9</sup>Be<sup>3+</sup> current was achieved after analyser magnet at terminal potential of 11MV. <sup>17</sup>O<sup>5+</sup> (from <sup>9</sup>Be<sup>17</sup>O) was collected in the offset Faraday cup with simultaneous recording of <sup>10</sup>Be counts in the MAGIC detector at 30mbar pressure of isobutane. This method works because the <sup>17</sup>O<sup>5+</sup>, &  ${}^{10}\text{Be}^{3+}$  has very close magnetic rigidity (matching within 1.1%) for terminal potential 10-12MV. For stopping <sup>10</sup>B in the gas cell absorber, 220 mbar pressure of Nitrogen was used. This is necessary because <sup>10</sup>B signal was about a million times stronger than <sup>10</sup>Be. Multi Anode Gas Ionization Chamber (MAGIC) has five anodes and one surface barrier detector at the end but for <sup>10</sup>Be detection it was used in the DE-E<sub>res</sub> mode using all anodes shorted to give one DE signal and the surface barrier signal as E<sub>res.</sub> Fig.1 shows the 2D spectrum obtained from MAGIC detector, with dE plotted against Eres.

In the spectrum <sup>7</sup>Be and some alpha is probably due to <sup>10</sup>B (p,  $\alpha$ ) <sup>7Be</sup> reaction happening at the front Myler foil of gas cell absorber. Much of alpha also comes from

fusion reaction of <sup>10</sup>B on nitrogen gas. <sup>9</sup>Be signal in the spectrum is due to <sup>9</sup>Be (from <sup>9</sup>Be<sup>16</sup>OH) stripping anywhere in the machine and entering the detector by matching analyser magnetic rigidity. It can be eliminated by Wien filter. Data was taken for ~ 2hours for one cathode with injected <sup>9</sup>Be<sup>16</sup>O current ~300nA. Result agrees to within 5-10% of known measured value  $2.68 \times 10^{-11}$  for SRM 4325.

Fig. 1. Two Dimensional spectrum of <sup>10</sup>Be measurement from standard sample obtained from MAGIC

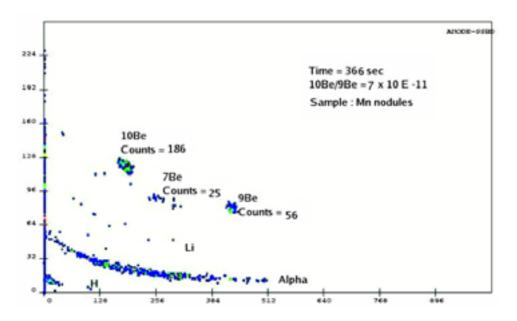
In the measurement of <sup>10</sup>Be from Mn sample all the old set of accelerator parameters for studying SRM 4325 were used. Fig.2 Shows 2D spectrum of <sup>10</sup>Be measurement from Mn Nodules sample. In the sample <sup>10</sup>Be/ <sup>9</sup>Be ratio was found to be 7 x 10<sup>-11</sup>, within error of ~10%.

Fig. 2 Two Dimensional spectrum of <sup>10</sup>Be measurement from Mn Nodules
