# 1. ACCELERATOR

## 1.1 PELLETRON

### 1.1.1 Operational Summary

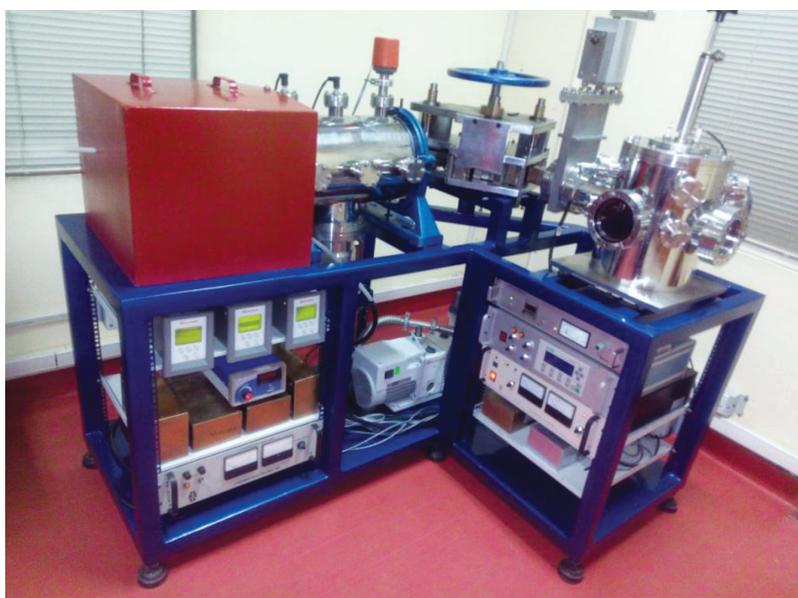
Fig. 1.6.1 IUAC's 60 kV Tabletop Accelerator

A new experimental chamber has been designed and installed providing more space & ports. HV toroid has been designed & installed on the ion source for better electric field distribution which has resulted in raising the maximum operating voltage from 50 kV to 60 kV. The accelerator stand has been modified to install the new bending magnet & experimental chamber. Energy table & picture of upgraded version of this accelerator is shown.

Beam Energy Range R=250 mm, Field: 1100 – 2600 G		
Element	Mass	Energy Range (keV)
H <sup>+</sup>	1	35 - 60
H <sub>2</sub> <sup>+</sup>	2	25 – 60
He <sup>+</sup>	4	25 – 50
He <sub>2</sub> <sup>+</sup>	4	50 – 120

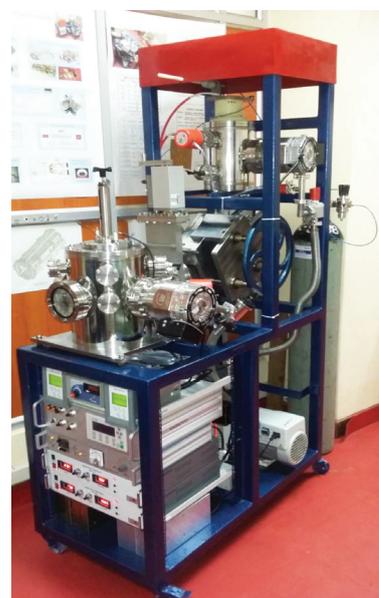
Fig. 1.6.2 IUAC's 30 kV Tabletop Accelerator
